EMSA/OP/01/2016

Study investigating cost effective measures for reducing the risk from fires on ro-ro passenger ships (FIRESAFE)

**European Maritime Safety Agency
SP Technical Research Institute of Sweden AB
Bureau Veritas
Stena Rederi AB**

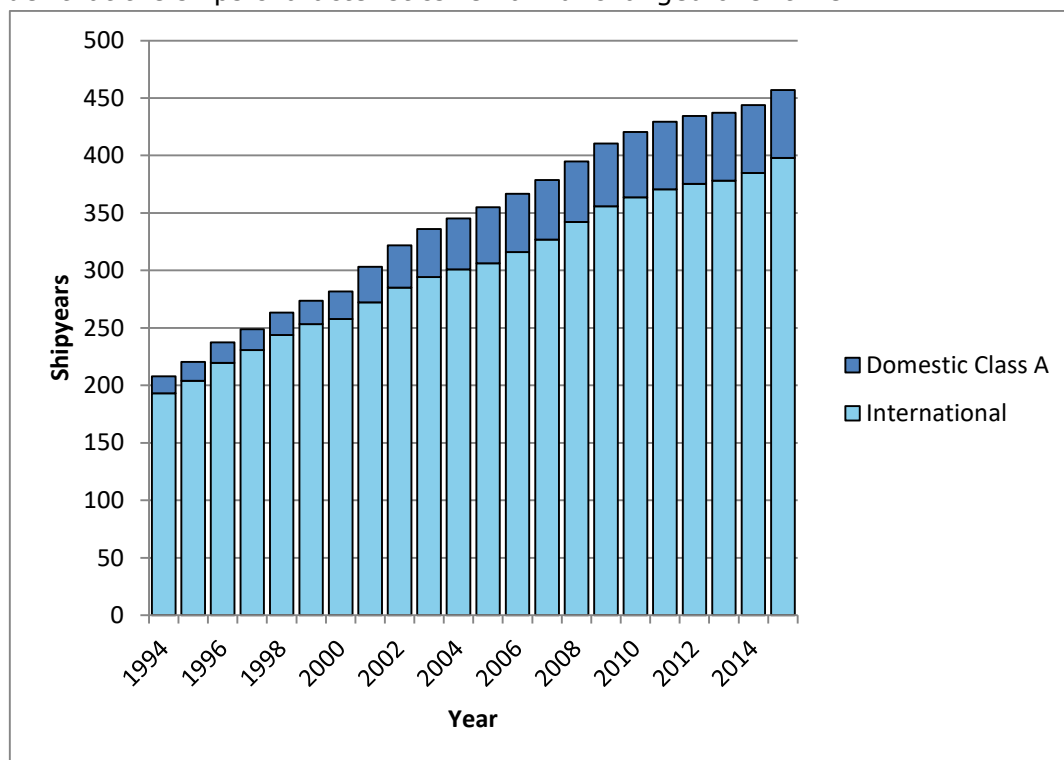
from about 210 shipyears in 1994 to 460 shipyears in 2015. The cause of this increase can be attributed to the filtering criteria selected for the study. The fleet under consideration consists of the ships compliant with the above-mentioned criteria. Each year, new ships enter the fleet (newbuildings compliant with the criteria), and contribute for additional shipyears, while almost no ships leave the fleet (since conversions are not considered and almost no scrapped or lost are observed). It seems a fair assumption to consider that the ships characteristics remain unchanged over time.

Figure 2.2-4: Number of shipyears per year for the FIRESAFE fleet between 1994 and 2015.

This led to a total of 7567 shipyears for the period 1994-2015, and 5530 shipyears for the period 2002-2015.

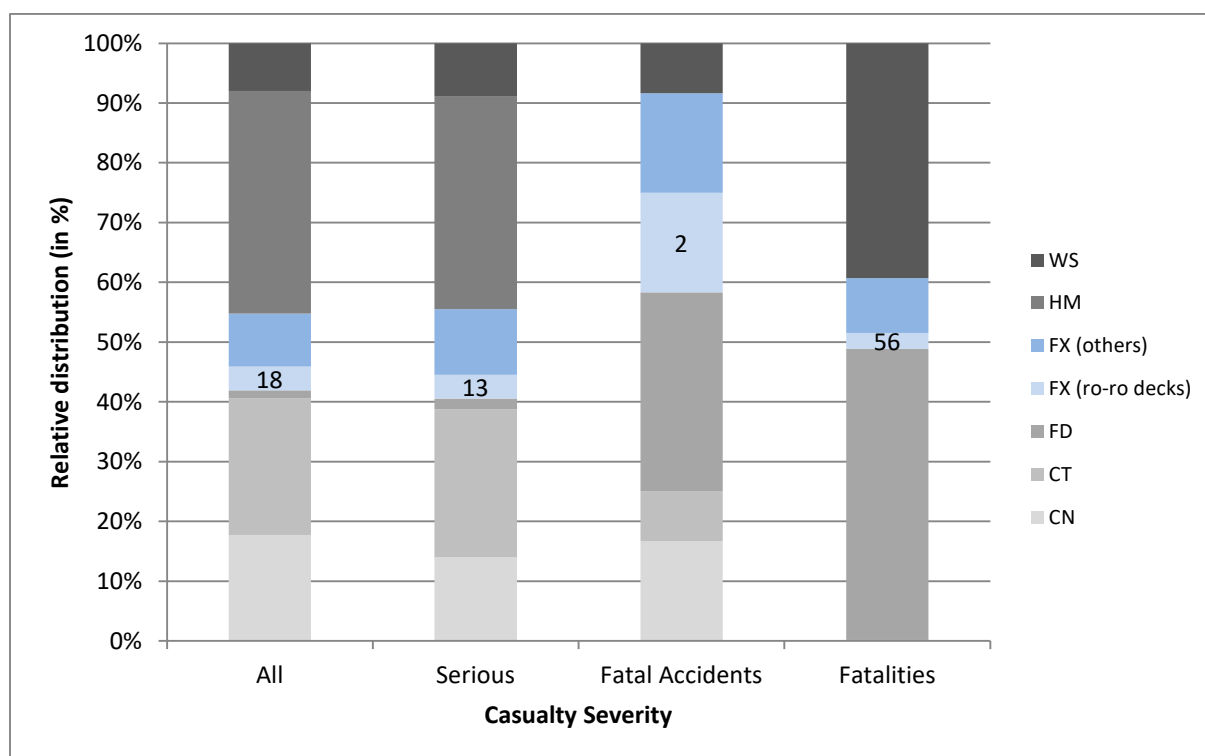
Figure 2.4-1: Relative distribution of casualty reports over the different accident categories on the FIRESAFE fleet between 2002 and 2015. Number of records for FX (ro-ro decks) provided by IHS. (WS: Wrecked/stranded, HM: Hull/machinery damage, FX: Fire/explosion, FD: Foundered, CT: Contact, CN: Collision)

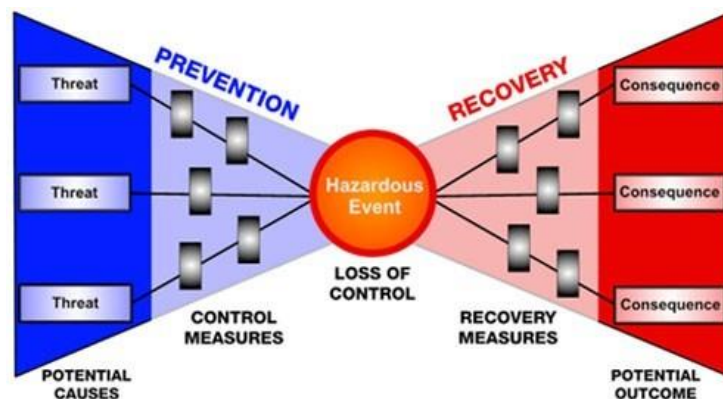
The concept used for the current Fire HazId was developed based on a well-known model in risk management called the Bow Tie model. It is a barrier risk model developed to assist the identification and management of hazards. The Bow Tie model is illustrated in Figure 2.5-1.

Figure 2.5-1. Illustration of the Bow Tie model, a barrier risk model for identification and management of hazards.

The Bow Tie model consists of different elements that build up the risk picture. The risk picture revolves around a hazardous top event. The top event is something with potential to cause harm unless it is controlled, in this case a ro-ro space fire. Focus is turned to one side at a time beginning with the threats on the left-hand side. These are potential causes for the top event which are explored through different escalation factors and control measures. Thereafter potential outcomes are investigated together with escalation factors and different recovery measures. The different control measures are barriers populated on either side of the model that are described by Table 2.5-1:
